**Flood Control Project Maintenance
Levee Inspections**
LMA District Cover Sheet
Spring 2016 Levee Inspection Results

Sutter Maintenance Yard East Levee Sacramento River

Spring 2016 Levee Inspection Results

Levee Inspection Report By Mile - Spring 2016

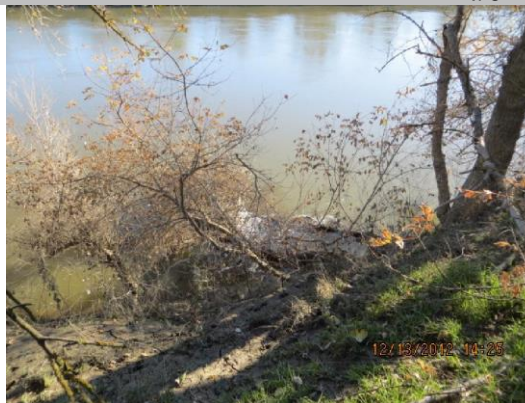
Photo 1 of 2 : UCIP_SP_2016_48512_46992.jpg

LM Start	1.44	Rating **	U	Issue No.	58 (cont)
LM End	1.44	Issue Type +	En	Location *	WS

Waterside view: overview of river bank

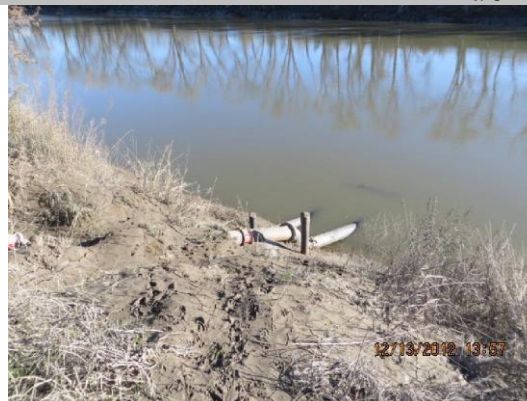
Photo 1 of 2 : UCIP_SP_2016_44138_47004.jpg

FS_ID:44138
DS_ID:17321
EP_NO: 9543
Repair Type: Urgent
Crossing Status: Found
UCIP Comments: 4/6/2015 Sloughing LS slope and river bank. DWR marking for leaky pipe.7/29/2013 Same as last inspection.12/30/2013 Same as last inspection.6/30/2014 Same as last inspection.
FIELD_STRUCT_DESC: 14-inch steel pipe encased in concrete through the levee 12.5 feet below the crown. Slant pump mounted on pile structure on berm. Slide gate in 48-inch riser on berm, walkway to pump. Discharges into concrete distribution box at landward toe. Flap gate on the landward end. (ABO No. 9543 - Harada). O&M manual 136, revision May 2011
FS Date: 4/7/2015 8:41:12 AM

LM Start	1.91	Rating **	U	Issue No.	39 (cont)
LM End	1.91	Issue Type +	En	Location *	WS

Waterside view: pipe @river bank

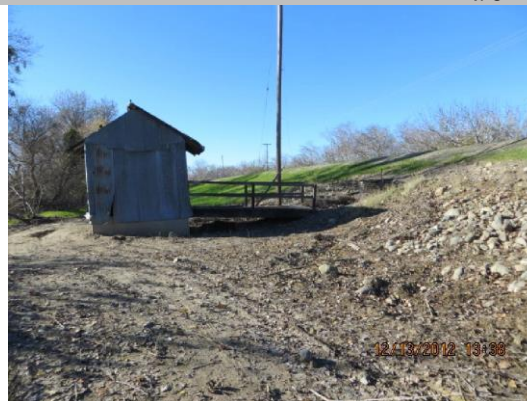
Photo 1 of 2 : UCIP_SP_2016_44139_47013.jpg

FS_ID:44139
DS_ID:17305
EP_NO: 9541
Repair Type: Non-Urgent
Crossing Status: Found
UCIP Comments: CMP standpipe with gate valve. Abandoned pump house. Pipe discharges into open ditch at landward toe- not found.4/6/2015 Same as last inspection.7/29/2013 Same as last inspection.12/30/2013 Same as last inspection.6/30/2014 Same as last inspection.
FIELD_STRUCT_DESC: Abandoned 24-inch pipe through the levee 13.5 feet below the crown, pump in metal house on berm. Slide gate in corrugated metal pipe riser on the waterward slope. Service pole and guy wire anchor on waterward slope. (ABO No. 9541 - Wilbur, McGowan, Zinke). O&M manual 136, revision May 2011
FS Date: 4/7/2015 8:42:33 AM

LM Start	2.08	Rating **	M	Issue No.	40 (cont)
LM End	2.08	Issue Type +	En	Location *	WS

Waterside view: overview

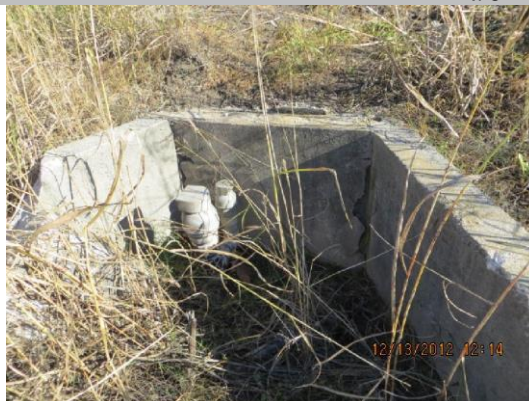
Photo 1 of 2 : UCIP_SP_2016_44146_47049.jpg

FS_ID:44146
DS_ID:17312
EP_NO: 9539
Repair Type: Non-Urgent
Crossing Status: Found
UCIP Comments: 4/6/2015 6in. and 18in. pipes still present in crossing and WS end still plugged with concrete.- it seems that the system was originally designed for drainage, later converted into irrigation system.

LM Start	3.41	Rating **	M	Issue No.	42 (cont)
LM End	3.41	Issue Type +	En	Location *	WS

Waterside view: plugged concrete structure and siphon breakers

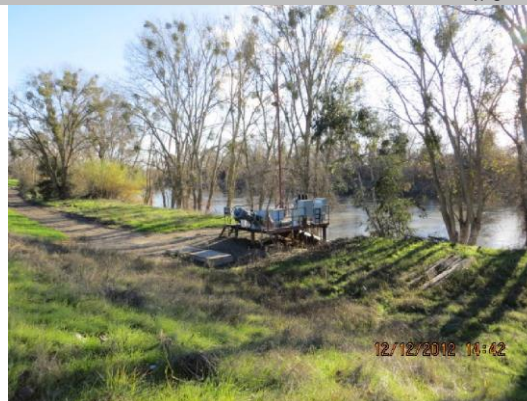
Photo 1 of 2 : UCIP_SP_2016_44177_47092.jpg

FS_ID:44177
DS_ID:17318
EP_NO: 10935
Repair Type: Urgent
Crossing Status: Found
UCIP Comments: 4/6/2015 Erosion problem still present near the LS shoulder. If it gets any worse then it may start to affect the road way. Found a siphon breaker on LS. Antenna and pump station on WS. Huge erosion on LS slope. 7/29/2013 Erosion near LS shoulder may start affecting the roadway if it gets any worse. 12/30/2013 Same as last inspection. 6/30/2014 Same as last inspection.
FIELD_STRUCT_DESC: 24-inch diameter steel pipe 4.0 feet below the crown. Slant pump on the waterside (WS) berm. A siphon breaker is installed on the apex of the pipe and off the levee crown on landside (LS). (Permit No. 9501, 1974 - Mayfair Farms, Inc., Permit No. 10935, 1975 - Pires).
FS Date: 4/7/2015 10:22:41 AM

LM Start	4.64	Rating **	U	Issue No.	20 (cont)
LM End	4.64	Issue Type +	En	Location *	WS

Waterside view: overview

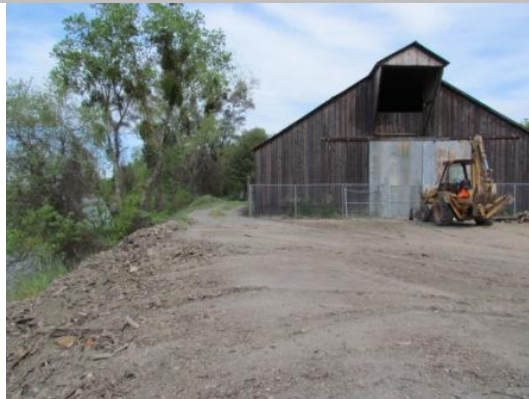
Photo 1 of 1 : SP_2016_ST0003_264_12_20160316_00007.jpg

LM Start	4.72	Rating **	U	Issue No.	12
LM End	4.72	Issue Type +	En	Location *	CR
Category	Earthen Levee			GPS Latitude/Longitude	
				Start	End
Item	Encroachments			39.213265 °	39.213265 °
				-121.991672 °	-121.991672 °
DWR ID	DWR_ST0003_01_s_2012_12				
Comment Code					
BU : Building					
Inspector Comment

View of the barn on the large crown of the levee.

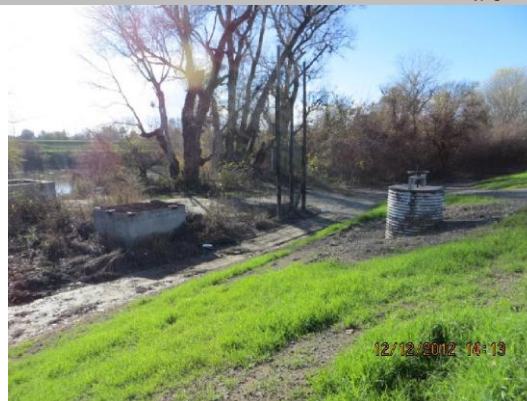
Photo 1 of 2 : UCIP_SP_2016_44182_47115.jpg

FS_ID:44182
DS_ID:17289
EP_NO: 2904
Repair Type: Urgent
Crossing Status: Found
UCIP Comments: 4/6/2015 Repairs are in progress to this crossing. Surge box on WS and distribution box across the county road on LS. Abandoned pump station and electrical panel on WS. A concrete pump pit on WS. 7/29/2013 Portable tow-pump lowered down WS berm to water level and is pumping water into concrete surge box on WS and the filling the irrigation ditch on LS. Sink hole with standing water that is present above the outlet pipe for the WS surge box. This may indicate a leaking pipe or cracked concrete. 12/30/2013 Sink Hole above pipe on WS still present. Pipe end inside of WS surge box shows heavy signs of rust and corrosion. Recommend having an internal camera inspection completed on pipe. 6/30/2014 Sink hole near WS surge box is still present. Portable pumps were lowered down the WS bank and were pumping water directly into WS standpipe on to by pass the surge box. FIELD_STRUCT_DESC: 36-inch corrugated metal pipe through the levee 18.4 feet below the crown. Slide gate in corrugate metal pipe riser on waterward shoulder, pump and concrete pump pit on the waterward bank. Concrete surge box on the waterward berm. Discharges into irrigation ditch on the opposite side of the county road. (App. No. 2904 - Arnold). Application was for an existing pumping system. O&M manual 136, revision May 2011.

LM Start	5.04	Rating **	U	Issue No.	22 (cont)
LM End	5.04	Issue Type +	En	Location *	CR

Waterside view: overview

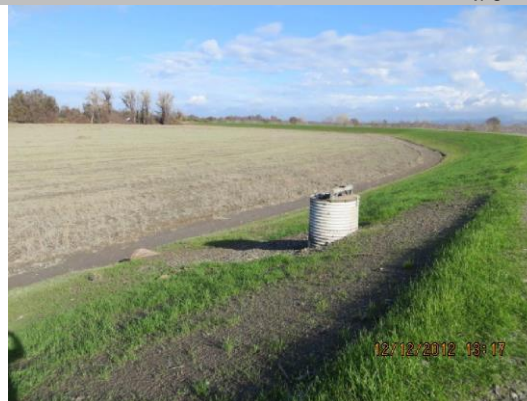
Photo 1 of 2 : UCIP_SP_2016_44208_47149.jpg

LM Start	6.08	Rating **	U	Issue No.	28 (cont)
LM End	6.08	Issue Type +	En	Location *	CR

Waterside view: overview

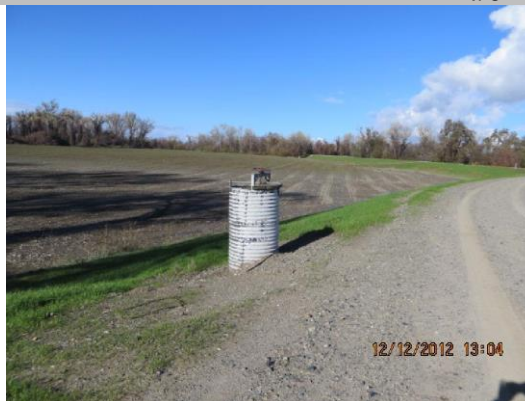
Photo 1 of 2 : UCIP_SP_2016_44209_47158.jpg

LM Start	6.40	Rating **	M	Issue No.	29 (cont)
LM End	6.40	Issue Type +	En	Location *	CR

Waterside view: CMP riser with slide gate

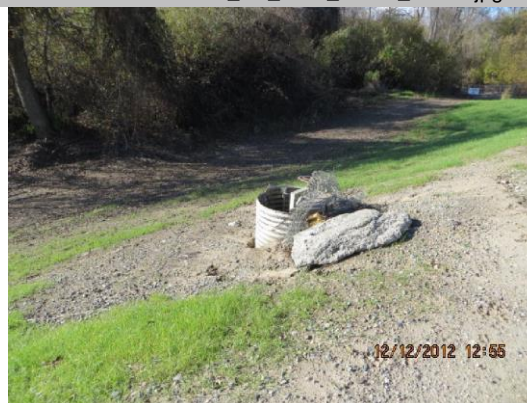
Photo 1 of 2 : UCIP_SP_2016_44211_47181.jpg

LM Start	6.64	Rating **	M	Issue No.	30 (cont)
LM End	6.64	Issue Type +	En	Location *	CR

Waterside view: CMP riser with slide gate

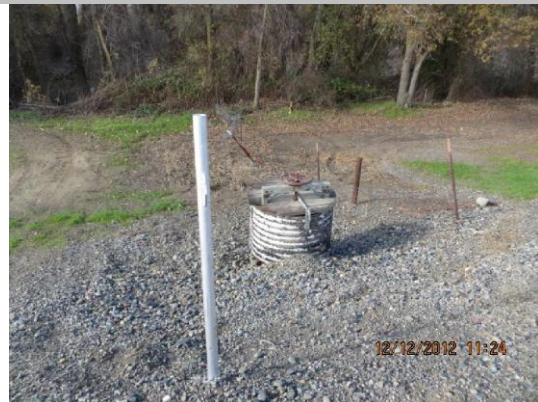
Photo 1 of 2 : UCIP_SP_2016_44243_47208.jpg

Comment Code					
Inspector Comment					
FS_ID:44243 DS_ID:17295 EP_NO: N/A Repair Type: Urgent Crossing Status: Found UCIP Comments: 4/1/2015 Both WS and LS pipe ends have been dug up in preparation for an internal camera inspection. Pipe shows signs of heavy rust and both ends of pipe are plugged with soil.Only a CMP riser with slide gate found on WS.7/23/2013 Same as last inspection.12/18/2013 Same as last inspection.6/30/2014 Same as last inspection. FIELD_STRUCT_DESC: Abandoned 24-inch irrigation and drain pipe through the levee. Slide gate in corrugated metal pipe riser on the waterward slope. Pipe invert 11.50 ft below the crown. O&M manual 136, revision May 2011. FS Date: 4/7/2015 2:01:56 PM

Waterside view: overview of CMP riser

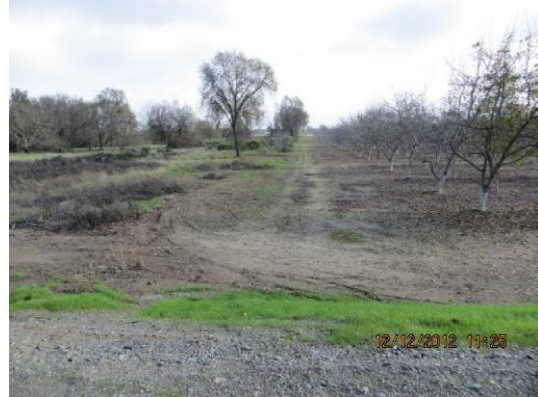
Photo 2 of 2 : UCIP_SP_2016_44243_47207.jpg

Comment Code						
Inspector Comment						
FS_ID:44243 DS_ID:17295 EP_NO: N/A Repair Type: Urgent Crossing Status: Found UCIP Comments: 4/1/2015 Both WS and LS pipe ends have been dug up in preparation for an internal camera inspection. Pipe shows signs of heavy rust and both ends of pipe are plugged with soil.Only a CMP riser with slide gate found on WS.7/23/2013 Same as last inspection.12/18/2013 Same as last inspection.6/30/2014 Same as last inspection. FIELD_STRUCT_DESC: Abandoned 24-inch irrigation and drain pipe through the levee. Slide gate in corrugated metal pipe riser on the waterward slope. Pipe invert 11.50 ft below the crown. O&M manual 136, revision May 2011. FS Date: 4/7/2015 2:01:56 PM

Landside view: overview (no pipes)

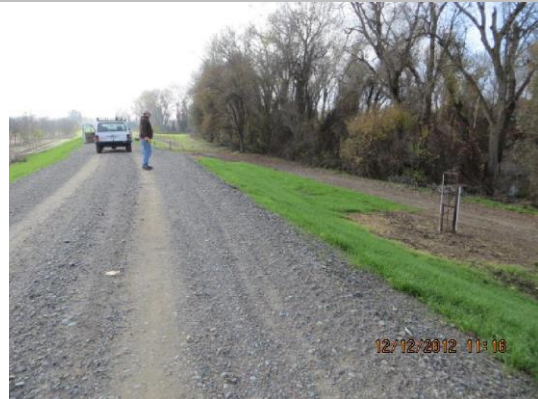
Photo 1 of 2 : UCIP_SP_2016_47702_47210.jpg

LM Start	8.56	Rating **	M	Issue No.	48
LM End	8.56	Issue Type +	En	Location *	WS
Category	Supplemental			GPS Latitude/Longitude	
				Start	End
Item	DWR UCIP Field Study			39.249678 °	39.249678 °
				-121.999021 °	-121.999021 °
DWR ID

Comment Code					
Inspector Comment					
FS_ID:47702 DS_ID:17327 EP_NO: 9528 Repair Type: Non-Urgent Crossing Status: Found UCIP Comments: 4/1/2015 Both ends of pipe have been dug up in preparation for internal camera inspections. Pipe shows some rust but appears to be in decent shape.Only buried slide gate structure found.7/23/2013 Same as last inspection.12/18/2013 Same as last inspection.6/30/2014 Same as last inspection.4/14/2016 Same as last inspection. FIELD_STRUCT_DESC: *ABANDONED* 24-inch corrugated metal drainpipe through the levee 12.5 feet below the crown. Slide gate on waterside (WS). O&M manual 136, revision May 2011. FS Date: 4/7/2015 2:21:00 PM

Waterside view: overview

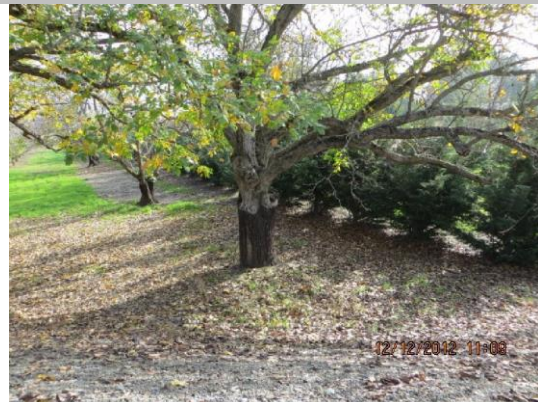
Photo 1 of 2 : UCIP_SP_2016_47707_74662.jpg

Comment Code					
Inspector Comment					
FS_ID:47707 DS_ID:17352 EP_NO: 9523 Repair Type: Non-Urgent Crossing Status: Indicator Found UCIP Comments: 8/28/2015 Pipe has been dug up and located along the WS levee toe. 7/23/2013 Same as last inspection. Unable to locate.12/18/2013 Unable to locate6/30/2014 Unable to locate.4/14/2016 Appears abandoned and if so, should be done so properly. Borrowing activity on landside (LS). FIELD_STRUCT_DESC: 10-inch concrete encased steel pipe through the levee, invert 15 ft below crown, not found. Gate valve found in 42-inch corrugated metal pipe riser on the waterside (WS) slope. (Permit No. 9523, 1974 - Blackmoor O&M manual 136, revision May 2011. FS Date: 4/14/2016 12:59:00 PM

View of LS

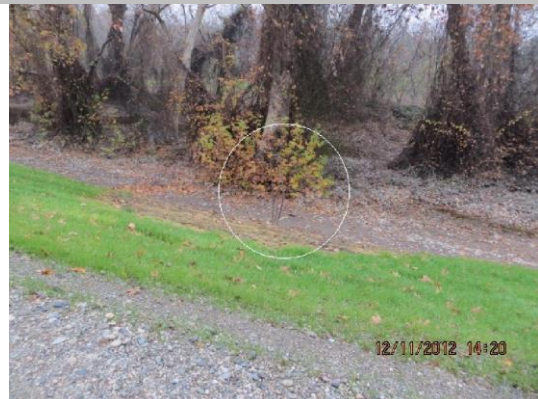
Photo 1 of 2 : UCIP_SP_2016_47708_47216.jpg

Comment Code					
Inspector Comment					
FS_ID:47708 DS_ID:17353 EP_NO: N/A Repair Type: Urgent Crossing Status: Found UCIP Comments: 8/28/2015 Pipe was dug up and located on the WS levee toe.7/23/2013 Same as last inspection.12/18/2013 Same as last inspection.6/30/2014 Same as last inspection.4/14/2016 Signs of corrosion on pipe and valve on LS. Pipe in use according to Bryan Reniff of Sutter Yard. FIELD_STRUCT_DESC: 4-inch steel pipe sleeved through 24-inch corrugated metal pipe 16.7 feet below the crown. Annular space has been pressure grouted. Slide gate on the waterside (WS) end. Gate valve at the landside (LS) toe. (Permit No. 4491, 1964 - Blackmore). O&M manual 136, revision May 2011. FS Date: 4/14/2016 1:59:00 PM

Waterside view: overview of slide gate on steel structure

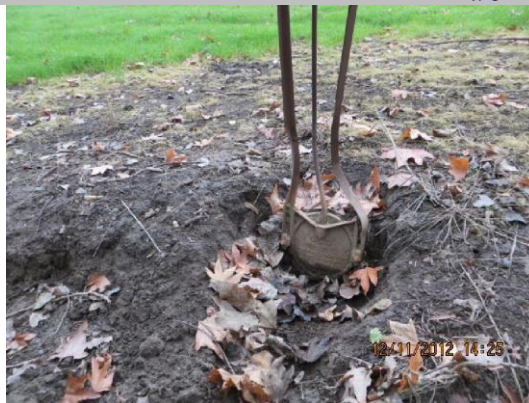
Photo 2 of 2 : UCIP_SP_2016_47708_47215.jpg

Comment Code						
Inspector Comment						
FS_ID:47708						
DS_ID:17353						
EP_NO: N/A						
Repair Type: Urgent						
Crossing Status: Found						
UCIP Comments: 8/28/2015 Pipe was dug up and located on the WS						
levee toe.7/23/2013 Same as last inspection.12/18/2013 Same as						
last inspection.6/30/2014 Same as last inspection.4/14/2016 Signs						
of corrosion on pipe and valve on LS. Pipe in use according to Bryan						
Reniff of Sutter Yard.						
FIELD_STRUCT_DESC: 4-inch steel pipe sleeved through 24-inch						
corrugated metal pipe 16.7 feet below the crown. Annular space has						
been pressure grouted. Slide gate on the waterside (WS) end. Gate						
valve at the landside (LS) toe. (Permit No. 4491, 1964 - Blackmore).						
O&M manual 136, revision May 2011.						
FS Date: 4/14/2016 1:59:00 PM

Waterside view: slide gate on steel structure

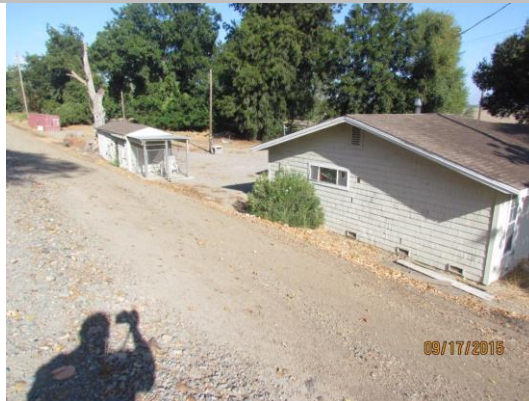
Photo 1 of 1 : SP_2016_ST0003_264_4_20160316_00003.jpg

LM Start	10.27	Rating **	M	Issue No.	4
LM End	10.27	Issue Type +	En	Location *	LS
Category	Earthen Levee			GPS Latitude/Longitude	
				Start	End
Item	Encroachments			39.270431 °	39.270431 °
				-121.999782 °	-121.999782 °
DWR ID	DWR_ST0003_01_s_2012_4				
Comment Code					
BU : Building					
Inspector Comment

View of the house and dog kennel at the landside toe.

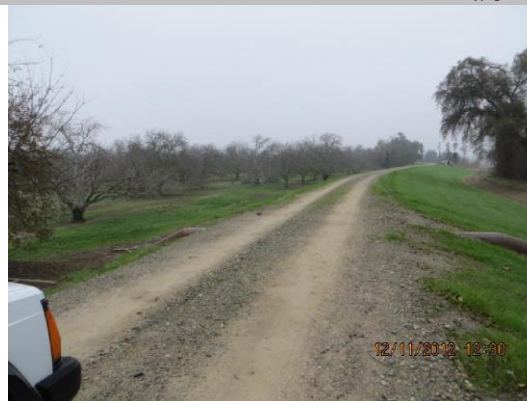
Photo 1 of 2 : UCIP_SP_2016_44449_47284.jpg

LM Start	10.69	Rating **	M	Issue No.	17 (cont)
LM End	10.69	Issue Type +	En	Location *	LS

Crown view: overview (both sides of the levee)

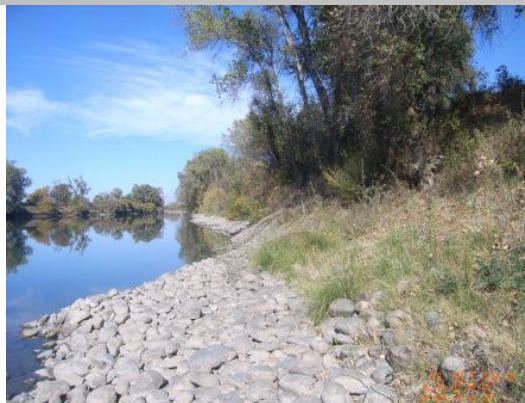
Photo 1 of 1 : SP_2016_ST0003_264_8_20160316_00004.jpg

LM Start	11.53	Rating **	M	Issue No.	8
LM End	11.79	Issue Type +	Ma	Location *	WS
Category	Supplemental			GPS Latitude/Longitude	
				Start	End
Item	2015 USACE Erosion Survey, DRAFT			39.279910 °	39.283853 °
				-122.018221 °	-122.016113 °
DWR ID	DWR_ST0003_01_s_2016_8				
Comment Code					
Inspector Comment					
2008 - Large rotational/mass failure in the bank with tree slump. 2009 - Minimal new erosion, the tree is leaning further into the river. 2011 - Site extended downstream. 2012 - Minor new erosion and tree roots are further exposed. 2015: Last observed in 2013. [2015 Site ID: SAC_152-6_L]

USACE 2013 Photo #1

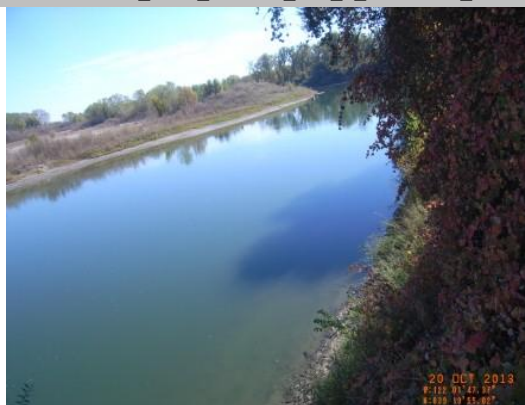
Photo 1 of 1 : SP_2016_ST0003_264_1_20160316_00001.jpg

LM Start	11.85	Rating **	M	Issue No.	1
LM End	11.90	Issue Type +	Ma	Location *	WS
Category	Supplemental			GPS Latitude/Longitude	
				Start	End
Item	2015 USACE Erosion Survey, DRAFT			39.331447 °	39.332716 °
				-122.029440 °	-122.029953 °
DWR ID	DWR_ST0003_01_s_2016_1				
Comment Code					
Inspector Comment					
2004 - Slowly eroding but near vertical with no vegetation to hold it. 2005 - Erosion is close to levee toe but not into the levee section yet. 2010 - Some new toe scour. 2015: Last observed in 2013. [2015 Site ID: SAC_157-7_R]

USACE 2013 Photo #1

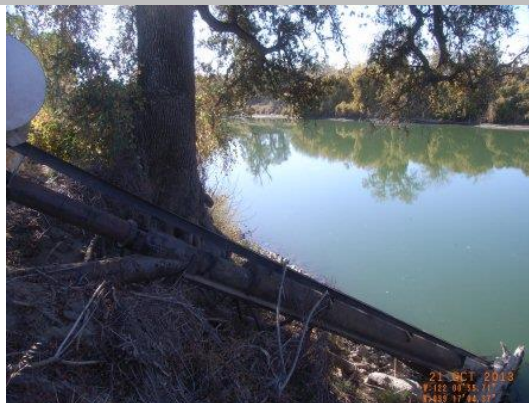
Photo 1 of 1 : SP_2016_ST0003_264_13_20160316_00008.jpg

LM Start	11.85	Rating **	M	Issue No.	13
LM End	11.90	Issue Type +	Ma	Location *	WS
Category	Supplemental			GPS Latitude/Longitude	
				Start	End
Item	2015 USACE Erosion Survey, DRAFT			39.284568 °	39.285298 °
				-122.015690 °	-122.015208 °
DWR ID	DWR_ST0003_01_s_2016_13				
Comment Code					
Inspector Comment					
2006 - Large rotational/mass failure in the bank with tree slump. Tough clayey toe material. 2007 - Site is between stone revetments with a pump station at the downstream end. 2010 - Erosion is into the levee toe. 2011 - Minor new erosion. 2012 - Minor new erosion. 2015: Last observed in 2013. [2015 Site ID: SAC_152-8_L]

USACE 2013 Photo #1

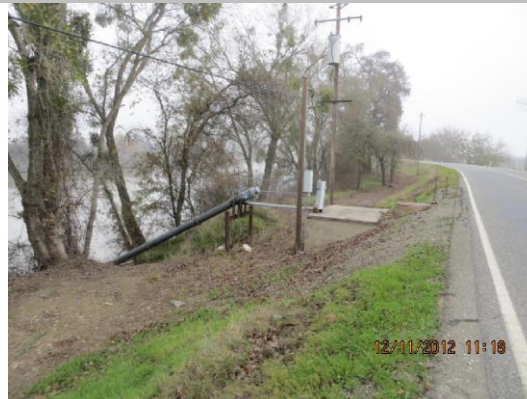
Photo 1 of 2 : UCIP_SP_2016_44465_47306.jpg

LM Start	12.06	Rating **	M	Issue No.	16 (cont)
LM End	12.06	Issue Type +	En	Location *	LS

Waterside view: overview pipe, pump, surge box & CMP riser

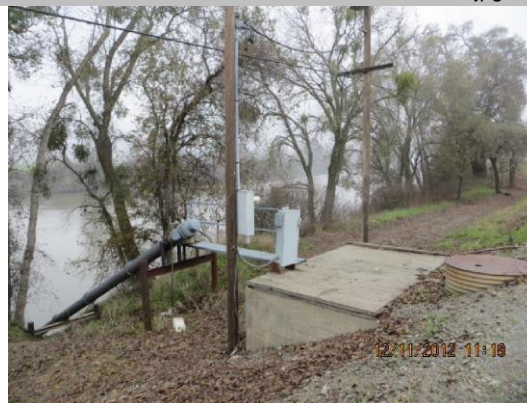
Photo 2 of 2 : UCIP_SP_2016_44465_47305.jpg

Waterside view: steel pipe, pump, surge box & CMP riser

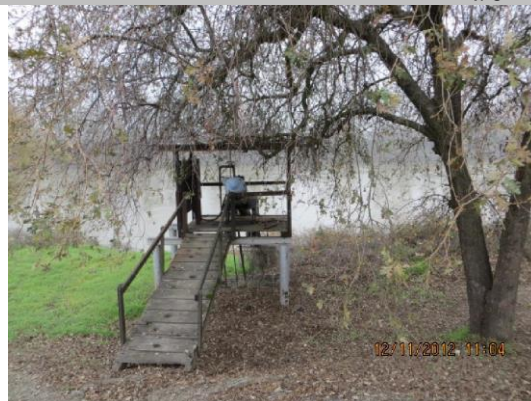
Photo 1 of 2 : UCIP_SP_2016_47711_47313.jpg

LM Start	12.43	Rating **	U	Issue No.	51 (cont)
LM End	12.43	Issue Type +	En	Location *	LS

Waterside view: overview of slanted pump and shed

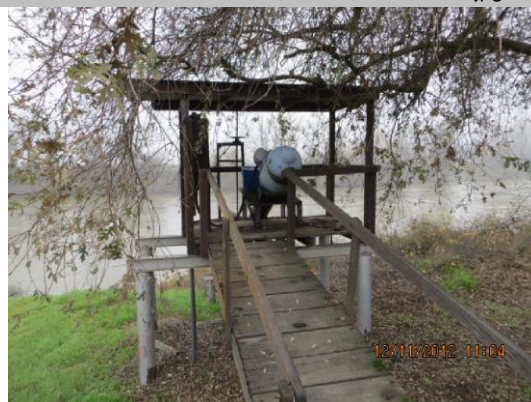
Photo 2 of 2 : UCIP_SP_2016_47711_47312.jpg

Waterside view: pump station and walkway

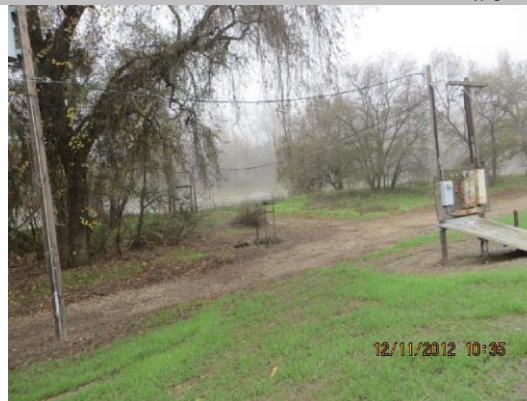
Photo 1 of 2 : UCIP_SP_2016_47770_47323.jpg

LM Start	12.56	Rating **	M	Issue No.	47 (cont)
LM End	12.56	Issue Type +	En	Location *	LS

Waterside view: overview

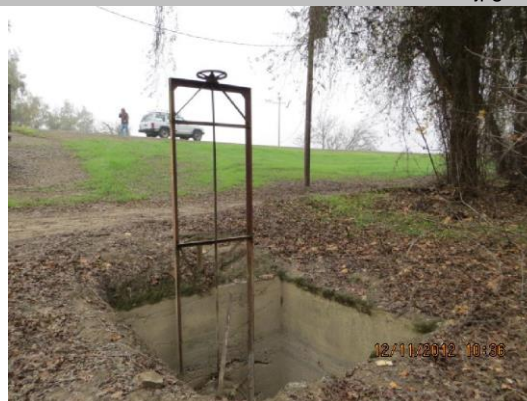
Photo 2 of 2 : UCIP_SP_2016_47770_47322.jpg

Waterside view: concrete surge box

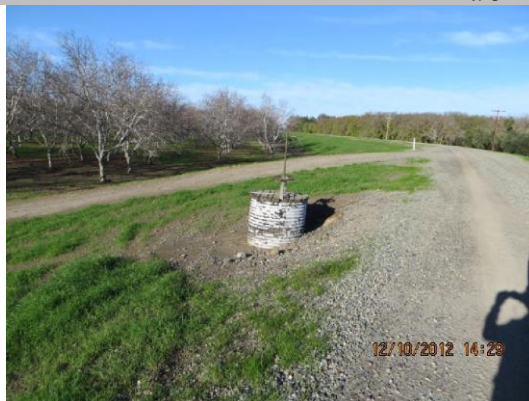
Photo 1 of 2 : UCIP_SP_2016_47906_47336.jpg

LM Start	12.96	Rating **	U	Issue No.	56 (cont)
LM End	12.96	Issue Type +	En	Location *	LS

Waterside view: CMP riser on levee slope.

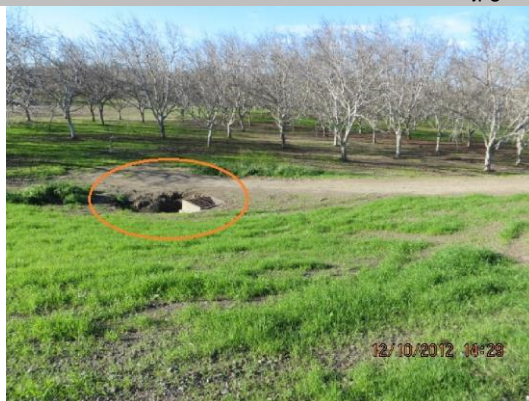
Photo 2 of 2 : UCIP_SP_2016_47906_47334.jpg

FS_ID:47906
DS_ID:17369
EP_NO: 9510
Repair Type: Urgent
Crossing Status: Found
UCIP Comments: 4/14/2016 Heavy scour still present around surge box on WS exposing pipe. Levee caved in and severely damaged around surge box. Erosion around CMP riser on WS cited previously not found. 4/2/2015 Pipe leaks during high water. It is suspected that the screw gate does not fully close and may need to be cleaned to allow it to close fully. Soil erosion around CMP riser and surge concrete box on WS damaged due to overflow. Pump not found. Flap gate missing on WS concrete box. WS slope eroded. Structure might have been used as drainage structure. This needs to be determined during routine inspection. 7/23/2013 Water was flowing from the WS to LS ditch. Not sure where water flow was originating. All erosion problems are still present. 12/19/2013 Same as last inspection. 7/2/2014 Same as last inspection.
FIELD_STRUCT_DESC: 36-inch corrugated metal pipe through the levee, 18.0 feet below the crown. Slide gate in 48-inch corrugated metal riser on the waterside (WS) slope. Concrete box on the WS. Pump mounted on WS bank, not found. (Permit No. 9510, 1974 - Forry). O&M manual 136, revision May 2011.

Waterside view: overview of concrete surge box

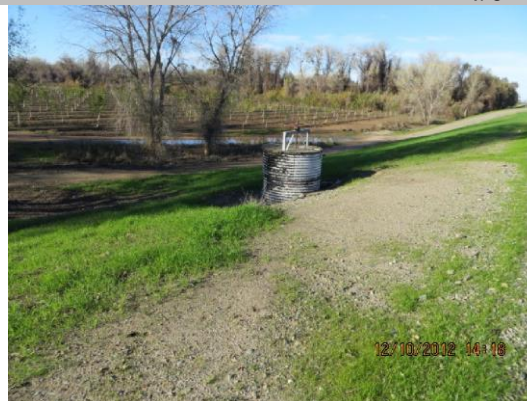
Photo 1 of 2 : UCIP_SP_2016_47999_47343.jpg

FS_ID:47999
DS_ID:17340
EP_NO: 9511
Repair Type: Non-Urgent
Crossing Status: Found
UCIP Comments: 4/16/2016 A wooden board has been placed on WS outlet of pipe to prevent sediment from entering pipe. This is a temporary fix by Sutter Yard until pipe can be grouted. Sutter Yard should contact owner to ensure pipe's proper abandonment. Blockage of pipe outlet by wooden board or sediment will pose a hazard during high water. 4/2/2015 Pipe has been selected for internal camera inspection. Outlet pipe silted on WS. Inlet structure damaged on LS. Not properly abandoned. 7/23/2013 Same as last inspection. 12/19/2013 Same as last inspection. 7/2/2014 Same as last inspection.
FIELD_STRUCT_DESC: *ABANDONED* 48-inch corrugated metal drainpipe through the levee, 16.5 feet below the crown. Slide gate in 60-inch corrugated metal pipe riser on the waterside (WS) slope. Landside (LS) end of pipe on east side of River Road. (Permit No. 9511, 1974 - Moresco). O&M manual 136, revision May 2011.

Waterside view: CMP riser with slide gate

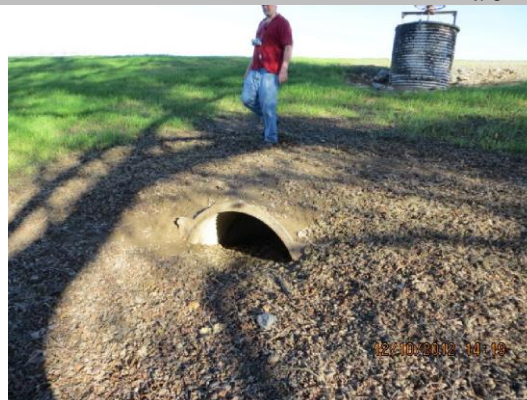
Photo 2 of 2 : UCIP_SP_2016_47999_47342.jpg

Waterside view: overview of CMP riser and outlet pipe

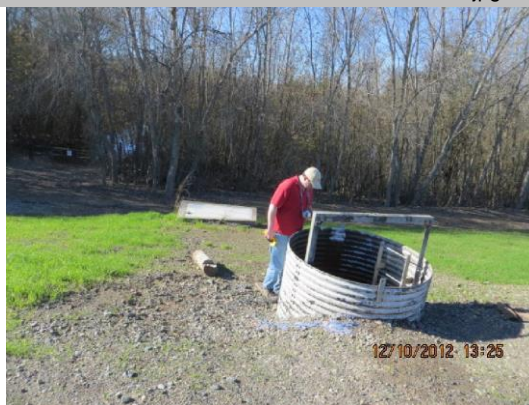
Photo 1 of 2 : UCIP_SP_2016_48078_47363.jpg

Comment Code					
Inspector Comment					
FS_ID:48078 DS_ID:17331 EP_NO: 1833 Repair Type: Non-Urgent Crossing Status: Found UCIP Comments: 4/14/2016 Levee slightly caved in one side of surge box on WS4/2/2015 Leaks during high water. Distribution box plugged with cement concrete on LS. Other concrete box plugged with concrete on WS. New steel pipe (about 16 inch diameter) sleeved through CMP pipe. It is visible inside CMP riser.7/2/2014 Same as last inspection.12/19/2013 Same as last inspection.7/23/2013 Same as last inspection. FIELD_STRUCT_DESC: 42-inch corrugated metal pipe (CMP) through the levee, 14.2 feet below the crown. A smaller, approximately 16-inch pipe has been sleeved through the 42-inch CMP, with annular space pressure grouted. Pump structure on the waterside (WS) bank, not found. Concrete surge box at the WS toe. Slide gate in CMP riser on the WS slope. Concrete distribution box on the landside (LS) across River Road. (Permit No. 1833, 1953 - Carter). O&M manual 136, revision May 2011. FS Date: 4/14/2016 12:24:00 PM

Waterside view: CMP riser with slide gate and surge box

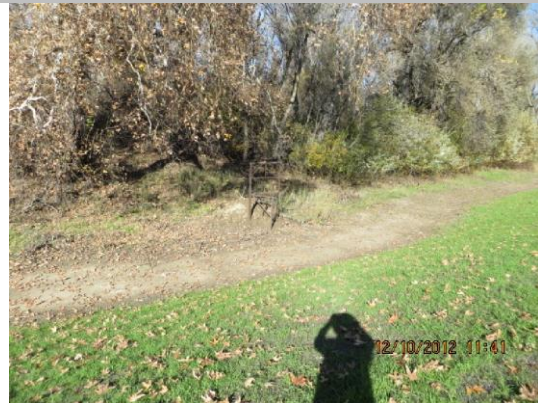
Photo 1 of 2 : UCIP_SP_2016_48101_47380.jpg

Comment Code					
Inspector Comment					
FS_ID:48101 DS_ID:17349 EP_NO: 9500 Repair Type: Non-Urgent Crossing Status: Indicator Found UCIP Comments: 4/16/2016 Same as last inspection. Appears abandoned and should be done so properly.4/2/2015 WS slide gate and LS distribution box are still silted over.Seems abandoned as slide gate and distribution box silted.7/2/2014 Same as last inspection.7/23/2013 Same as last inspection.12/19/2013 Same as last inspection. FIELD_STRUCT_DESC: *ABANDONED* 48-inch corrugated metal irrigation and drain pipe through the levee, 17.0 feet below the crown. Slide gate on the waterside (WS). 8-inch steel pipe sleeved through the 48-inch pipe during the summer months. Discharges into concrete distribution box at the landside (LS) toe. (Permit No. 9500, 1974 - Zumwalt). O&M manual 136, revision May 2011. FS Date: 4/14/2016 1:06:00 PM

Waterside view: overview of slide gate

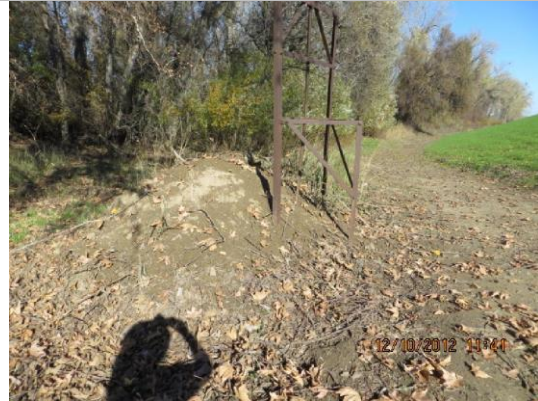
Photo 2 of 2 : UCIP_SP_2016_48101_47379.jpg

Item	DWR UCIP Field Study			39.345635 °	39.345635 °	
				-122.022915 °	-122.022915 °	
DWR ID						
Comment Code						
Inspector Comment						
FS_ID:48101 DS_ID:17349 EP_NO: 9500 Repair Type: Non-Urgent Crossing Status: Indicator Found UCIP Comments: 4/16/2016 Same as last inspection. Appears abandoned and should be done so properly.4/2/2015 WS slide gate and LS distribution box are still silted over.Seems abandoned as slide gate and distribution box silted.7/2/2014 Same as last inspection.7/23/2013 Same as last inspection.12/19/2013 Same as last inspection. FIELD_STRUCT_DESC: *ABANDONED* 48-inch corrugated metal irrigation and drain pipe through the levee, 17.0 feet below the crown. Slide gate on the waterside (WS). 8-inch steel pipe sleeved through the 48-inch pipe during the summer months. Discharges into concrete distribution box at the landside (LS) toe. (Permit No. 9500, 1974 - Zumwalt). O&M manual 136, revision May 2011. FS Date: 4/14/2016 1:06:00 PM

Waterside view: slide gate on steel structure

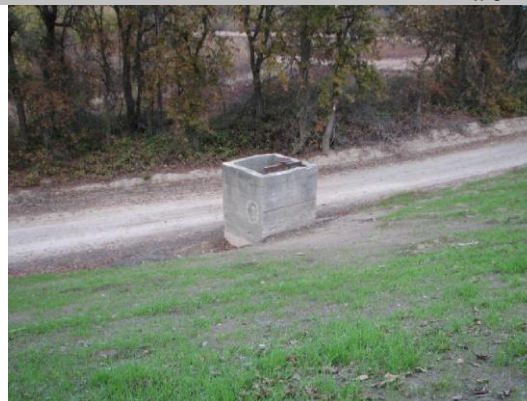
Photo 1 of 2 : UCIP_SP_2016_44491_47394.jpg

Comment Code					
Inspector Comment					
FS_ID:44491 DS_ID:17343 EP_NO: 9502 Repair Type: Non-Urgent Crossing Status: Found UCIP Comments: 4/2/2015 Same as last inspection. Vertical pump on bank not found as bank is not accessible. An abandoned electrical switch found on waterside. Landside distribution box is filled with debris and soil. Crossing appears abandoned and should be verified as having been done so properly. 7/24/2013 Same as last inspection.12/19/2013 Same as last inspection.7/2/2014 Same as last inspection. FIELD_STRUCT_DESC: 36-inch corrugated metal pipe through the levee, 18.0 feet below the crown. Vertical pump on bank. Slide gate in concrete box at the waterward toe. Discharges into concrete distribution box at the landward toe. Pole on the waterward shoulder. (ABO No. 9502 - Coffman, and Application No. 11540). O&M manual 136, revision May 2011. FS Date: 4/16/2015 1:39:44 PM

Waterside view: overview of gate riser

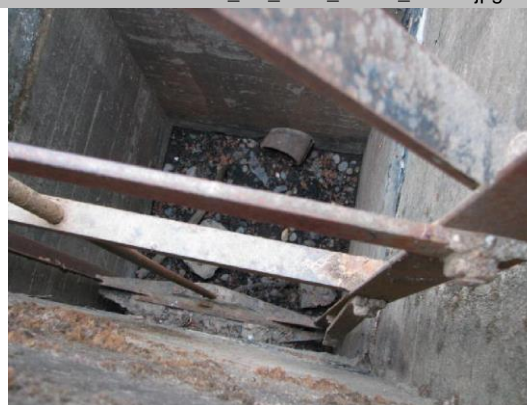
Photo 2 of 2 : UCIP_SP_2016_44491_47392.jpg

Waterside view: inside gate riser

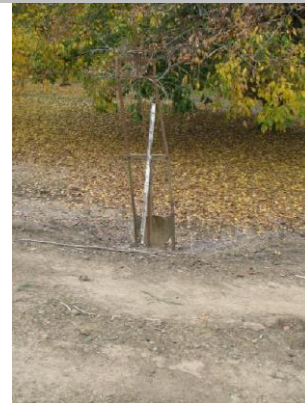
Photo 1 of 2 : UCIP_SP_2016_48105_47442.jpg

Comment Code					
Inspector Comment					
FS_ID:48105 DS_ID:17346 EP_NO: 9503 Repair Type: Non-Urgent Crossing Status: Found UCIP Comments: 4/14/2016 Inlet structure still filled with soil.4/2/2015 Same as last inspection. Pipe has been selected for internal camera inspection.According to local people, the crossing is functional. The gap between 8-inch and 24-inch pipes is grouted with cement. Inlet structure is filled with soil.7/2/2014 Same as last inspection.12/19/2013 Same as last inspection.7/24/2013 Same as last inspection. FIELD_STRUCT_DESC: 24-inch corrugated metal drain pipe through the levee, 19 feet below the crown, with 8-inch steel pipe sleeved through it. Annular space cement grouted. Slide gate at waterside (WS) toe and concrete inlet box on landside (LS) of the levee. (Permit No. 9503, 1974 - Baird). O&M Manual 136, revision May 2011. FS Date: 4/14/2016 2:22:00 PM

Waterside view: overview of slide gate structure

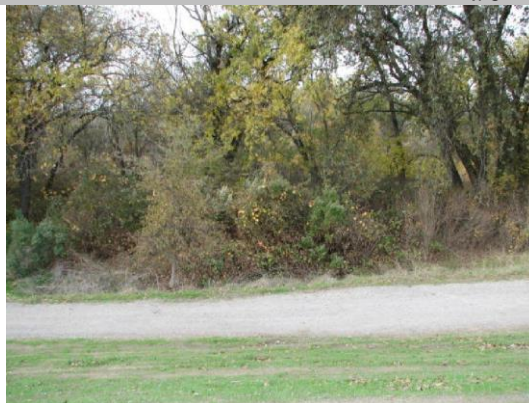
Photo 1 of 2 : UCIP_SP_2016_44500_47449.jpg

LM Start	19.55	Rating **	M	Issue No.	43
LM End	19.55	Issue Type +	En	Location *	LS
Category	Supplemental			GPS Latitude/Longitude	
				Start	End
Item	DWR UCIP Field Study			39.375221 °	39.375221 °
				-121.995878 °	-121.995878 °
DWR ID					
Comment Code					
Inspector Comment					
FS_ID:44500 DS_ID:17487 EP_NO: N/A Repair Type: Non-Urgent Crossing Status: Found UCIP Comments: 4/2/2015 Same as last inspection.Slide Gate WS not found. An abandoned pump and steel pipe found on WS. A 6 ft x 8 ft concrete distribution box with a CMP found on LS. Box filled with soil. An abandoned crossing.7/24/2013 Same as last inspection.12/19/2013 Same as last inspection.7/2/2014 Same as last inspection. FIELD_STRUCT_DESC: 36 inch pipe, 21.7 ft invert below crown. O&M manual 136, revision May 2011. FS Date: 4/16/2015 2:33:22 PM

Waterside view: overview

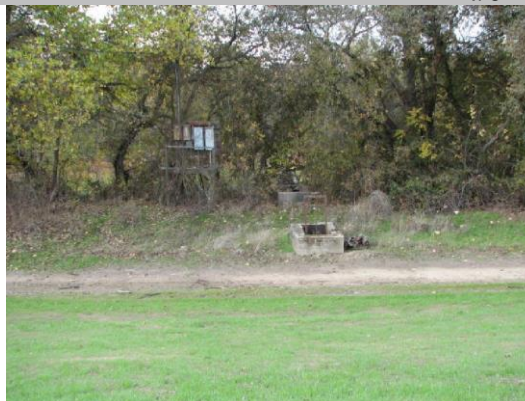
Photo 1 of 2 : UCIP_SP_2016_44501_47459.jpg

Comment Code					
Inspector Comment					
FS_ID:44501 DS_ID:17370 EP_NO: 9496 Repair Type: Non-Urgent Crossing Status: Found UCIP Comments: 4/2/2015 Same as last inspection.Only one pump found on WS. An abandoned surge box found on WS and pipe is grouted with cement. Two 16-inch steel pipe found on pump station along with two electrical conduits. A concrete distribution box found on LS with 20-inch CMP. Appears abandoned crossing.7/24/2013 Same as last inspection.12/19/2013 Same as last inspection. 7/2/2104 Same as last inspection. FIELD_STRUCT_DESC: 20-inch corrugated metal pipe through the levee, 19.8 feet below the crown. Two vertical pumps on pile structure on the waterward bank. Slide gate in concrete surge box on the waterward berm. Discharges into concrete distribution box on the landward side across the county road. Switch board on platform on bank. (ABO No. 9496 Womble). O&M manual 136, revision May 2011. FS Date: 4/16/2015 2:35:52 PM

Waterside view: overview

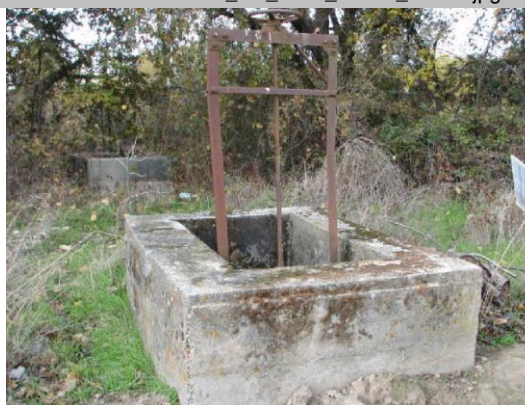
Photo 2 of 2 : UCIP_SP_2016_44501_47457.jpg

Waterside view: gate riser with slide gate

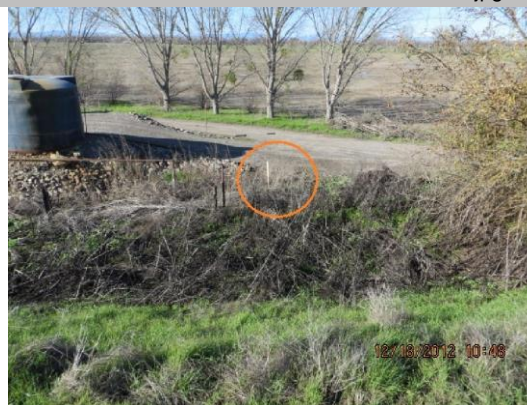
Photo 1 of 2 : UCIP_SP_2016_44506_47480.jpg

LM Start	1.20	Rating **	M	Issue No.	2
LM End	1.20	Issue Type +	En	Location *	LS
Category	Supplemental			GPS Latitude/Longitude	
				Start	End
Item	DWR UCIP Field Study			39.229526 °	39.229526 °
				-121.975686 °	-121.975686 °
DWR ID					
Comment Code					
Inspector Comment					
FS_ID:44506 DS_ID:17531 EP_NO: 13534 Repair Type: Non-Urgent Crossing Status: Indicator Found UCIP Comments: 4/6/2015 Same as last inspection.May need to add more substantial gasoline markers.7/22/2013 Same as last inspection.12/19/2013 Same as last inspection.7/7/2014 Same as last inspection. FIELD_STRUCT_DESC: 2-1/2 inch steel gas pipeline through the levee 2.5 feet below the crown. (13534 - Texaco Incorporated). A gasoline indicator found on LS. FS Date: 4/16/2015 2:44:41 PM

Landside view: overview gasline indicator

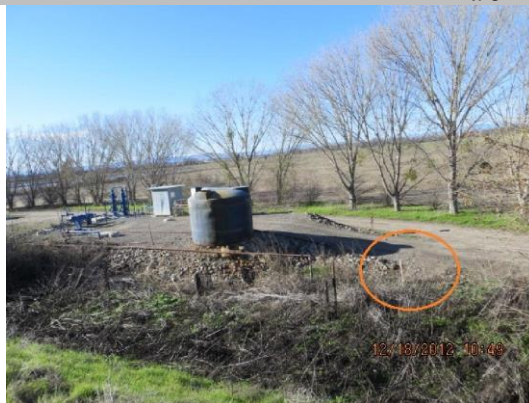
Photo 2 of 2 : UCIP_SP_2016_44506_47479.jpg

LM Start	1.20	Rating **	M	Issue No.	2 (cont)	
LM End	1.20	Issue Type +	En	Location *	LS	
Category	Supplemental			GPS Latitude/Longitude		
				Start		End
Item	DWR UCIP Field Study			39.229526 °		39.229526 °
				-121.975686 °		-121.975686 °
DWR ID						
Comment Code						
Inspector Comment						
FS_ID:44506 DS_ID:17531 EP_NO: 13534 Repair Type: Non-Urgent Crossing Status: Indicator Found UCIP Comments: 4/6/2015 Same as last inspection.May need to add more substantial gasoline markers.7/22/2013 Same as last inspection.12/19/2013 Same as last inspection.7/7/2014 Same as last inspection. FIELD_STRUCT_DESC: 2-1/2 inch steel gas pipeline through the levee 2.5 feet below the crown. (13534 - Texaco Incorporated). A gasoline indicator found on LS. FS Date: 4/16/2015 2:44:41 PM

Landside view: overview gasoline indicator

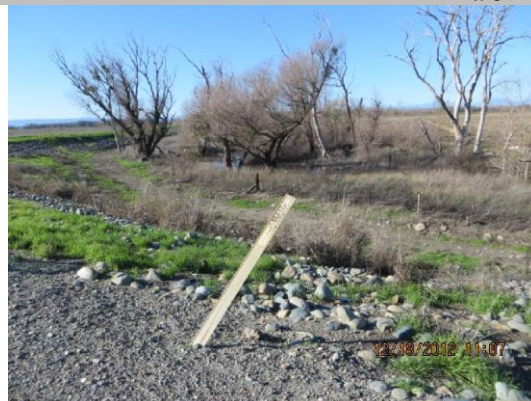
Photo 1 of 2 : UCIP_SP_2016_44508_47486.jpg

FS_ID:44508
DS_ID:17558
EP_NO: 15821
Repair Type: Non-Urgent
Crossing Status: Indicator Found
UCIP Comments: 4/6/2015 Same as last inspection. May need to add additional gasline markers. 7/22/2013 Same as last inspection. 12/19/2013 Same as last inspection. 7/7/2014 Same as last inspection.
FIELD_STRUCT_DESC: 3 of 3. 4-inch natural gas pipeline under both levees and the Colusa Bypass with a distance of 12 inches between them and two inches on either side of the trench. Only one gasline indicator found on LS.
FS Date: 4/16/2015 2:47:17 PM

Landside view: gasline indicator

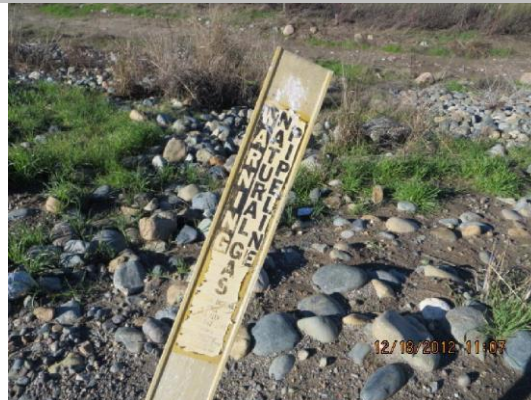
Photo 2 of 2 : UCIP_SP_2016_44508_47485.jpg

Landside view: gasline indicator close look

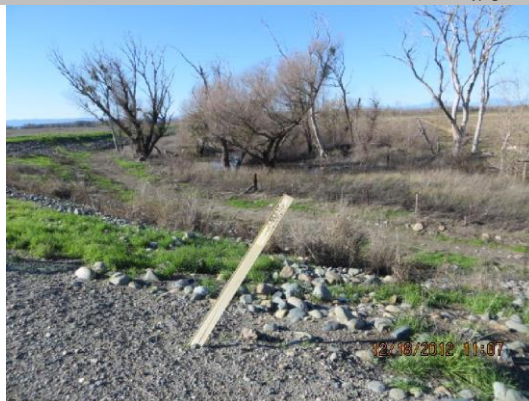
Photo 1 of 2 : UCIP_SP_2016_44509_47482.jpg

FS_ID:44509
DS_ID:17556
EP_NO: 15821
Repair Type: Non-Urgent
Crossing Status: Indicator Found
UCIP Comments: 4/6/2015 Same as last inspection.May need to add additional gasline markers.7/22/2013 Same as last inspection.12/19/2013 Same as last inspection.7/7/2014 Same as last inspection.
FIELD_STRUCT_DESC: 1 of 3. 4-inch natural gas pipeline under both levees and the Colusa Bypass with a distance of 12 inches between them and two inches on either side of the trench. One gasline indicator found on LS.
FS Date: 4/16/2015 2:47:45 PM

Landside view: gasline indicator

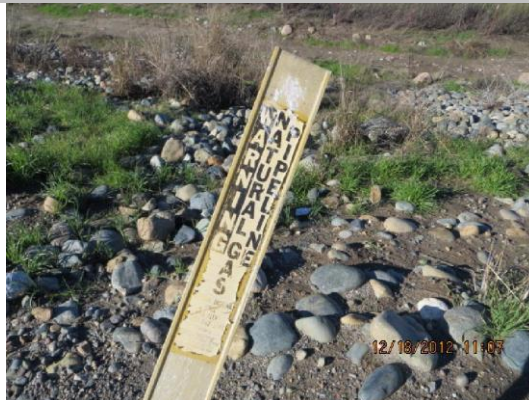
Photo 2 of 2 : UCIP_SP_2016_44509_47481.jpg

Landside view: gasline indicator close view
